**PROPERTY CONDITION ASSESSMENT
OF
WORLD TRADE CENTER PORTFOLIO**

ONE WORLD TRADE CENTER

Merritt & Harris, Inc. Project Number 20-251E

Re: **Due Diligence Physical Condition Survey**
World Trade Center
New York, New York

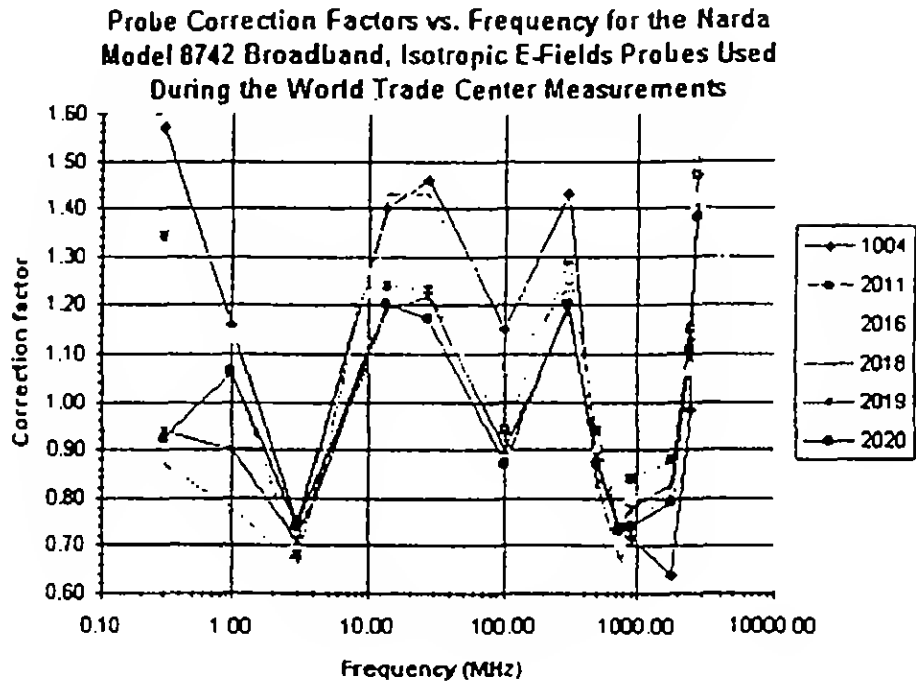
Figure 4. Graph showing the distribution of correction factors for the Narda Model 8742 broadband, isotropic frequency shaped electric field probes used during the WTC RF measurement project. The probe with serial number 1004 was not used during the actual survey process due to its generally greater correction factor at most frequencies. All probe correction factors are seen to comply with the manufacturer's specification of a maximum deviation of ± 2 dB from the frequency variation of the standard for human exposure adopted by the FCC in the frequency range of 0.5 MHz to 2,000 MHz.

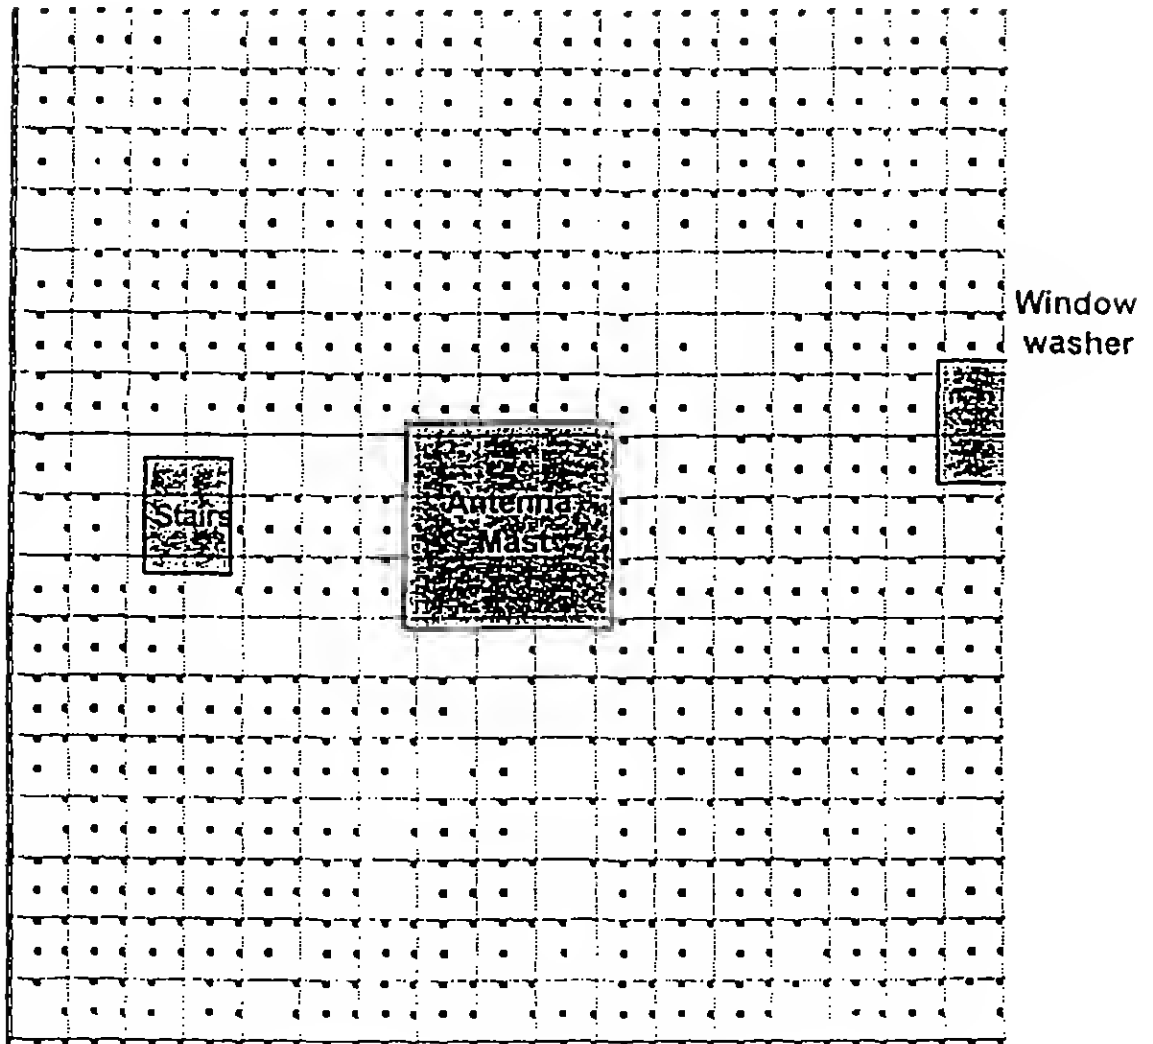
The measurement plan called for excluding measurements in the very close vicinity (within 2.5 feet) of metallic structures including antennas, cable trays, lights or any other features that could materially perturb the local field strengths. This practice reduced the total number of roof-top measurement points from a potential of 1,225 down to 889. Figure 5 illustrates these 889 measurement points and shows the areas allocated to the stairwell, antenna mast and window washer unit.

Figure 5. WTC roof map showing the location and distribution of all included 889 measurement points. The overall measurement area was 170 feet by 170 feet with measurement points spaced generally five feet apart except when a point fell within 2.5 feet of an existing roof-mounted antenna or other metallic structure such as cable trays and roof-mounted lights that might perturb the local fields.

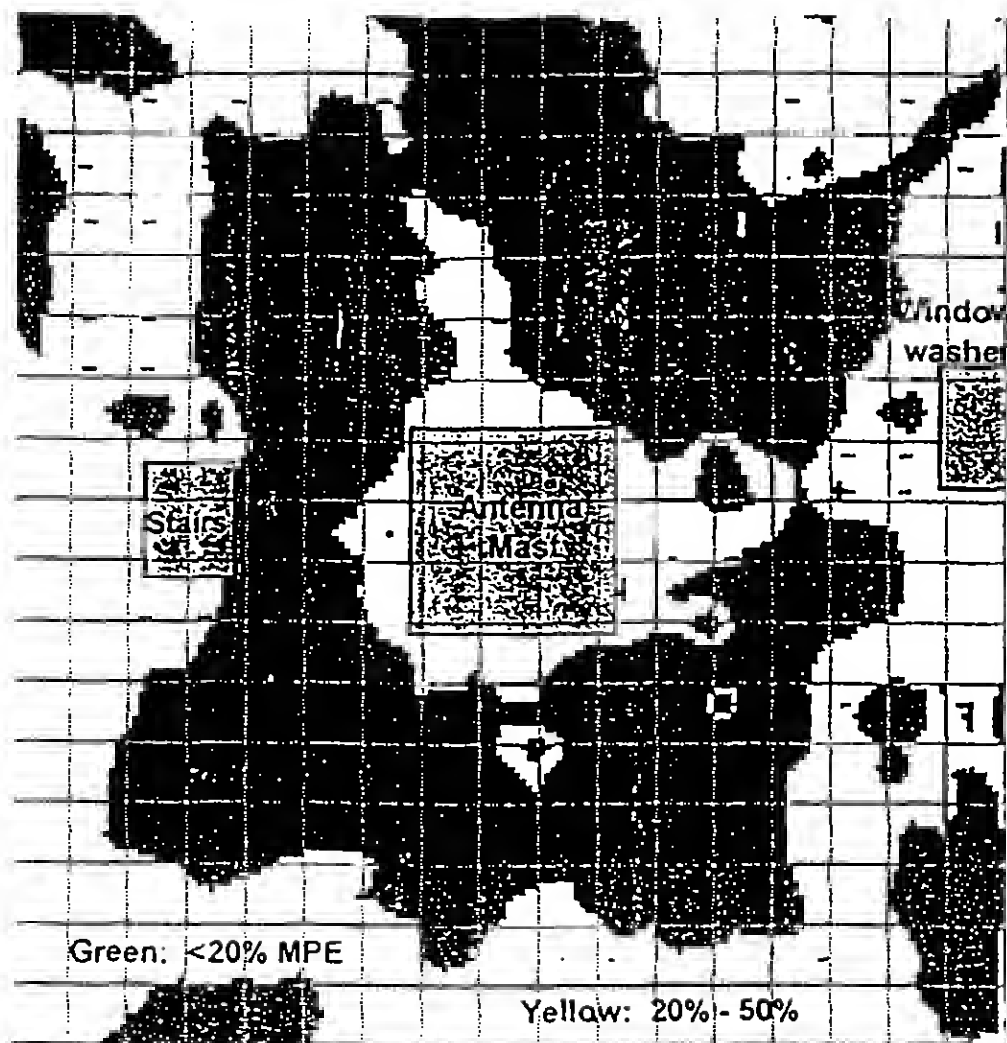
If the contribution of the 72 MHz paging links is removed, in a fashion like that described above, the resulting roof map, shown in Figure 13, shows that the maximum RF field level has been reduced from 147% of the MPE to 138% and the extent of the roof area that is subject to fields exceeding the lower, general public MPE is slightly decreased to 94.3% of the roof surface. This condition projects the expected ambient RF field levels

Figure 13. Roof map of RF fields during tower maintenance mode with contribution of 72 MHz paging links removed with RoofView. Maximum field is 138.3% MPE.

Statistical summary of RF Fields on WTC roof (see Figure 13)		
Percent occupational MPE range (%)	Roof area in this range (ft ²)	Percent of roof area in this range (%)
0-20	1546	5.68
21-50	13108	48.18
51-100	12035	44.24
>100	516	1.90

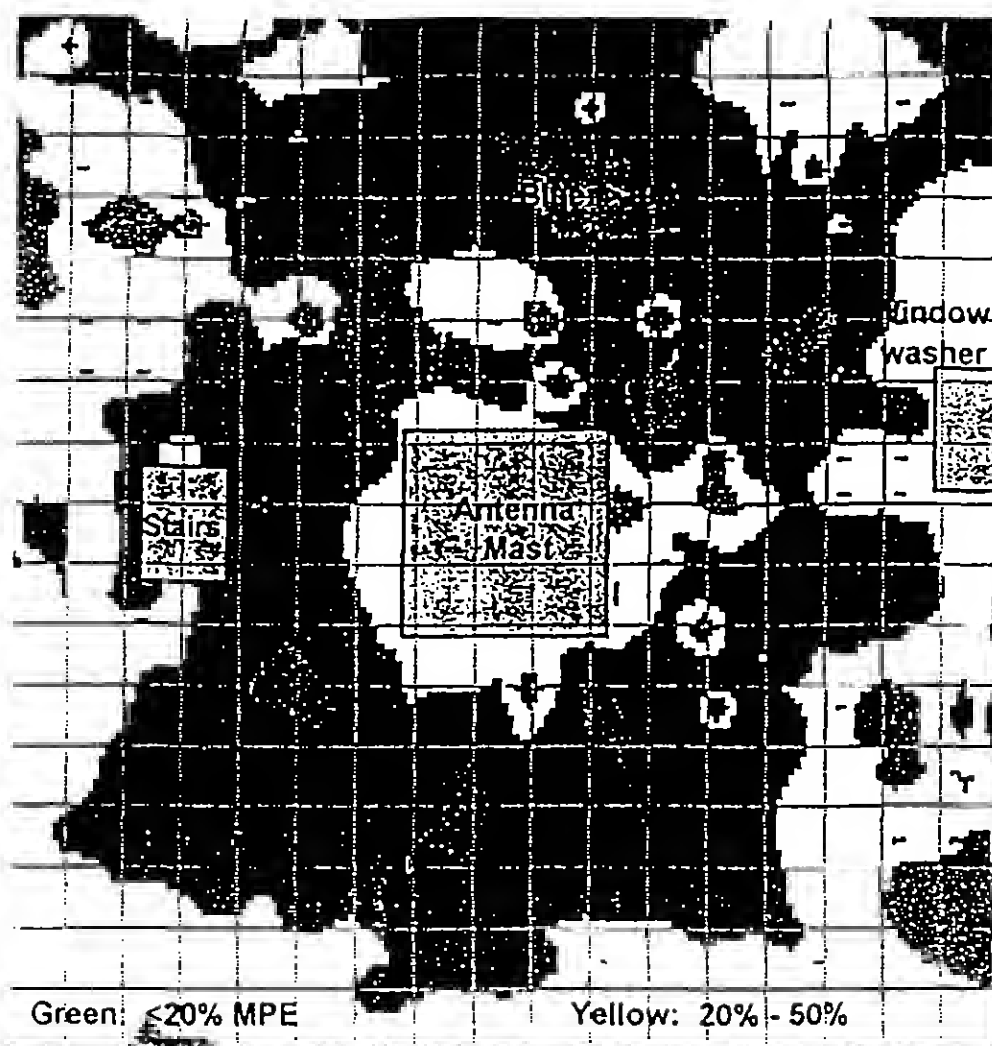
If the contributions of the 72 MHz paging links or any other wireless antennas are removed from the measured ambient fields, the maximum RF field is projected to reduce to 135% of the MPE with a resulting roof map as illustrated in Figure 17. When this is done, the amount of roof area with fields less than the general public MPE is increased from less than 1% previously to more than 4%. However, there is still 3.25% of the roof (corresponding to 888 ft²) that is subject to fields exceeding 100% of the MPE.

Figure 17. Roof map of emergency backup broadcast ambient RF fields with contribution of 72 MHz paging links removed via analysis with RoofView. Maximum field is 135 2% MPE.

Statistical summary of RF Fields on WTC roof (see Figure 17)		
Percent occupational MPE range (%)	Roof area in this range (ft ²)	Percent of roof area in this range (%)
0-20	1135	4.17
21-50	11034	40.56
51-100	14148	52.01
>100	888	3.26

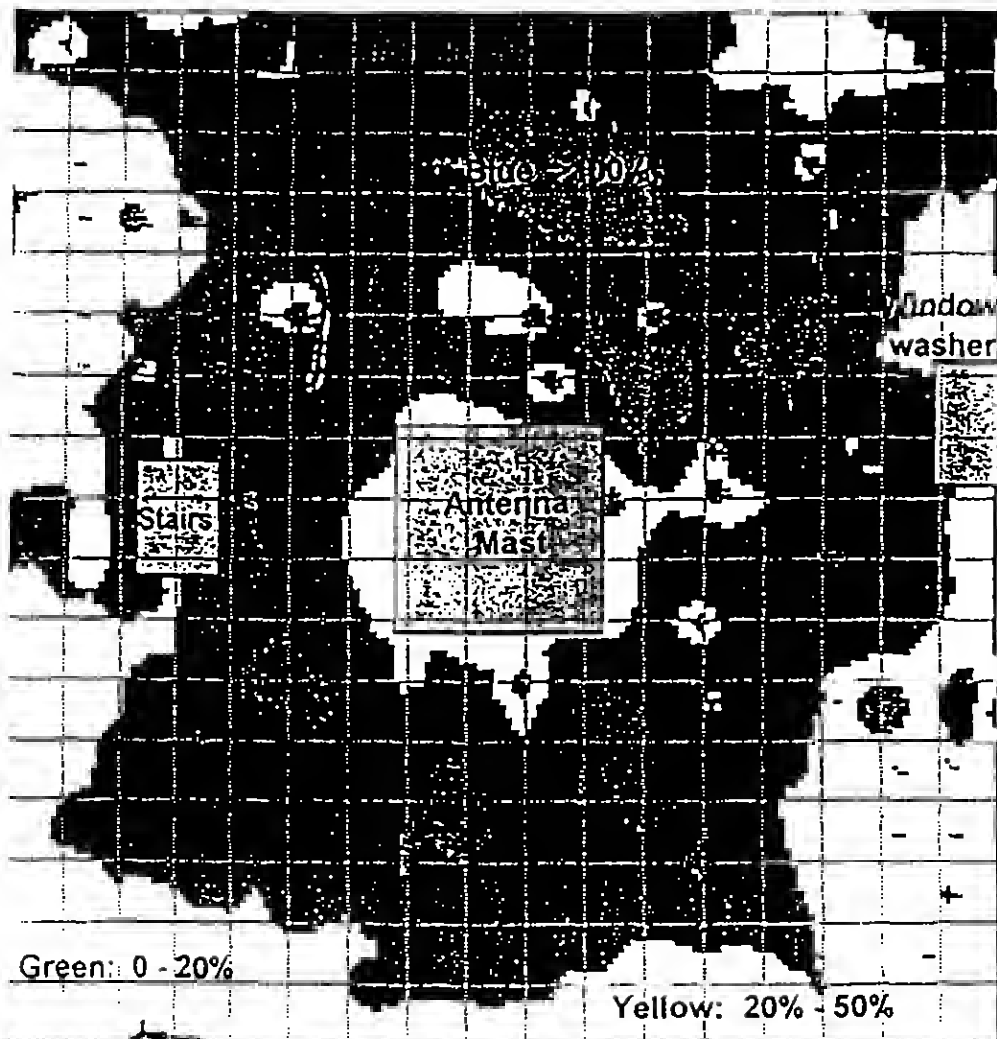
Figure 18. Roof map of RF fields during emergency broadcast backup operations with calculated effect of all wireless antennas raised at least 6 feet above roof level. Maximum field is 149.3% MPE.

Statistical summary of RF Fields on WTC roof (see Figure 18)		
Percent occupational MPE range (%)	Roof area in this range (ft ²)	Percent of roof area in this range (%)
0-20	249	0.92
21-50	9104	33.46
51-100	16151	59.37
>100	1701	6.25

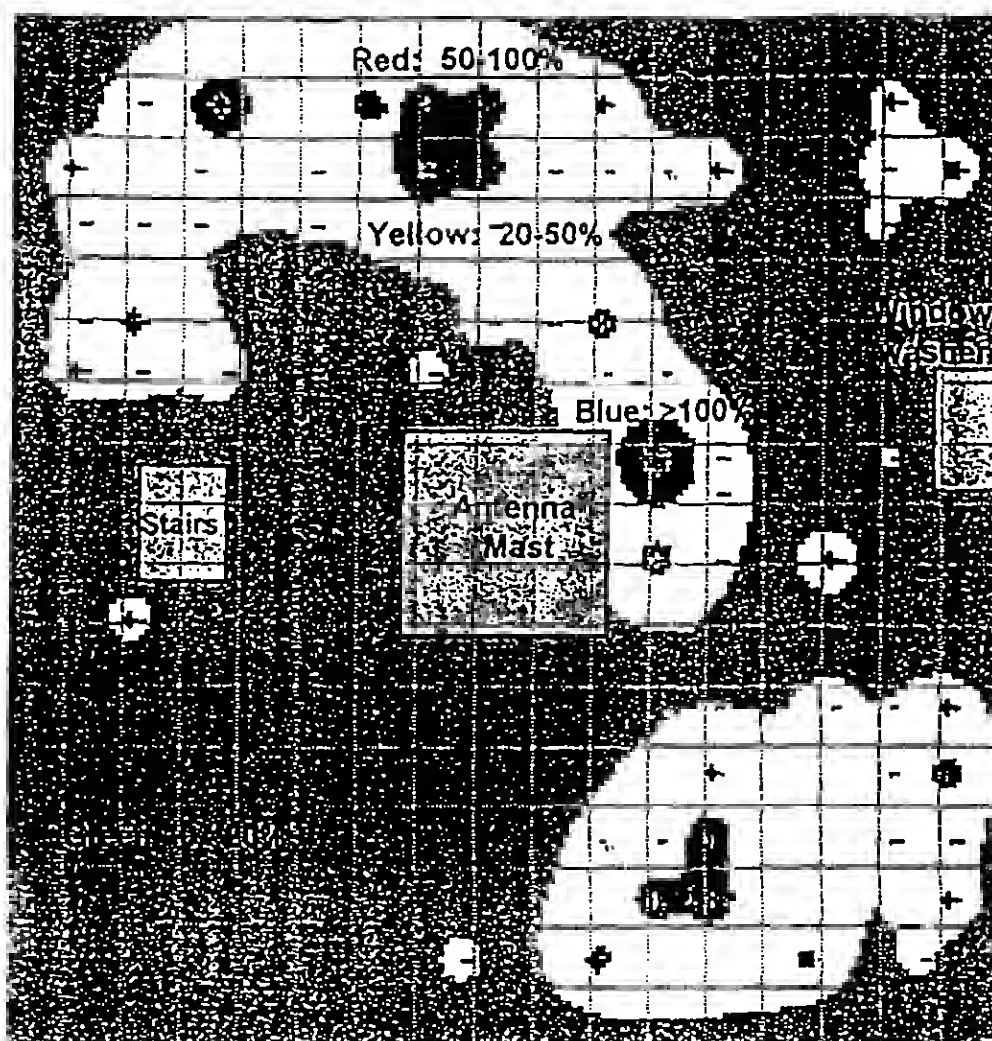
Figure 19. RoofView computed roof map for all wireless telecommunications antennas assumed operating but without contribution of RF fields from any of 72 MHz paging links or any contribution from broadcasting facilities. Maximum field is 273.9% MPE.

Statistical summary of RF Fields on WTC roof (see Figure 19)		
Percent occupational MPE range (%)	Roof area in this range (ft ²)	Percent of roof area in this range (%)
0-20	17324	63.68
21-50	8960	32.94
51-100	833	3.06
>100	88	0.32

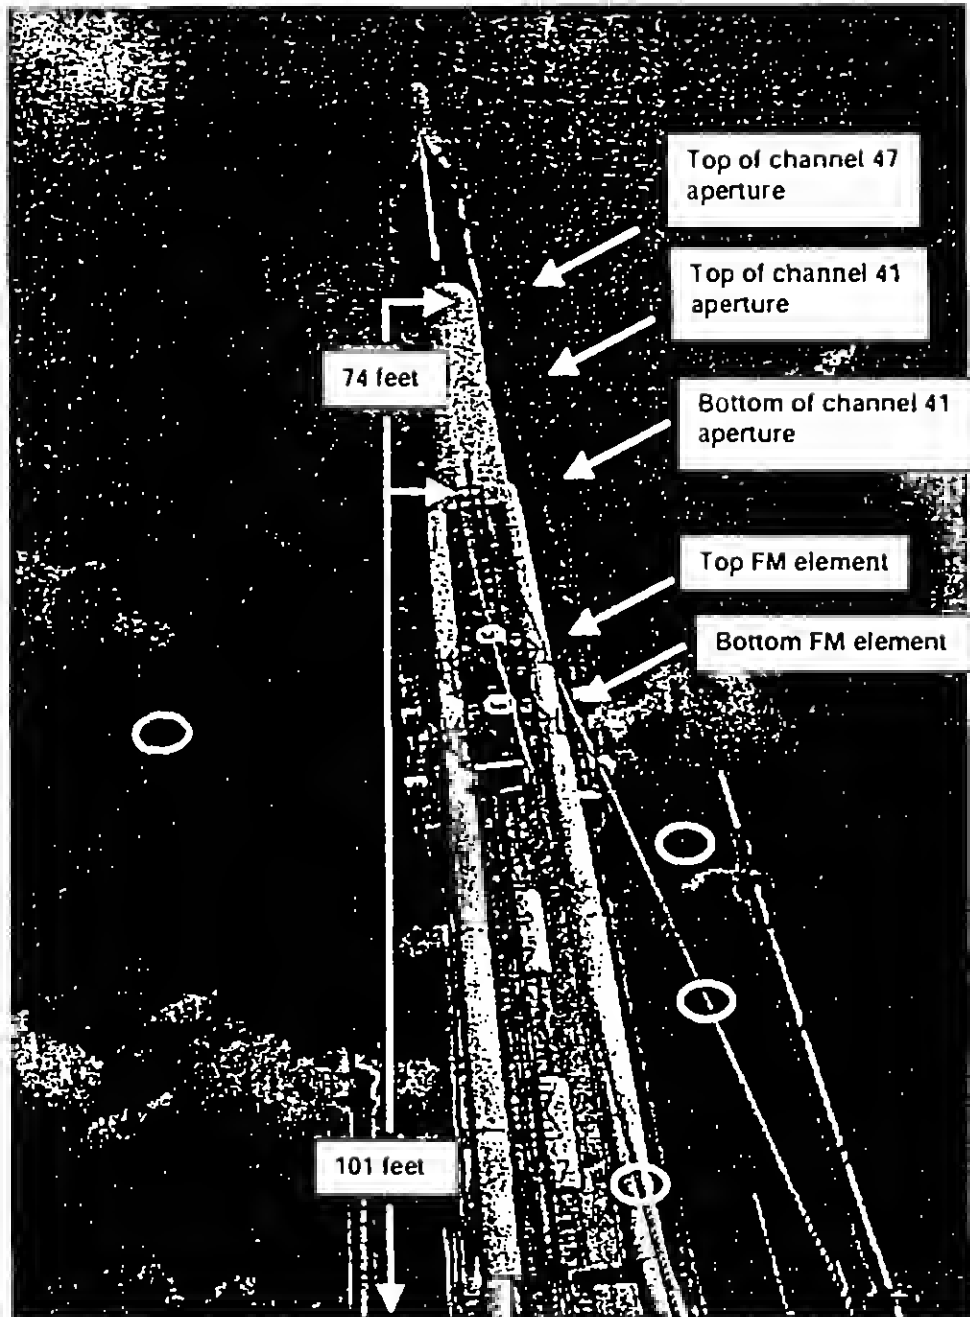
Figure 3. View of the antenna mast on the World Trade Center north tower showing ropes rigged to ice shield at top of the channel 47 antenna aperture. During measurements, the bottom ends of the ropes were brought from their temporary anchor points near the edge of the roof to the base of the mast and rigged over pulleys to facilitate up and down movement of the electric field strength probe. The principal working area that will be used during the antenna work is shown. The lower dimension is relative to the TV mast interface on the roof. Ropes are highlighted with ovals around them.

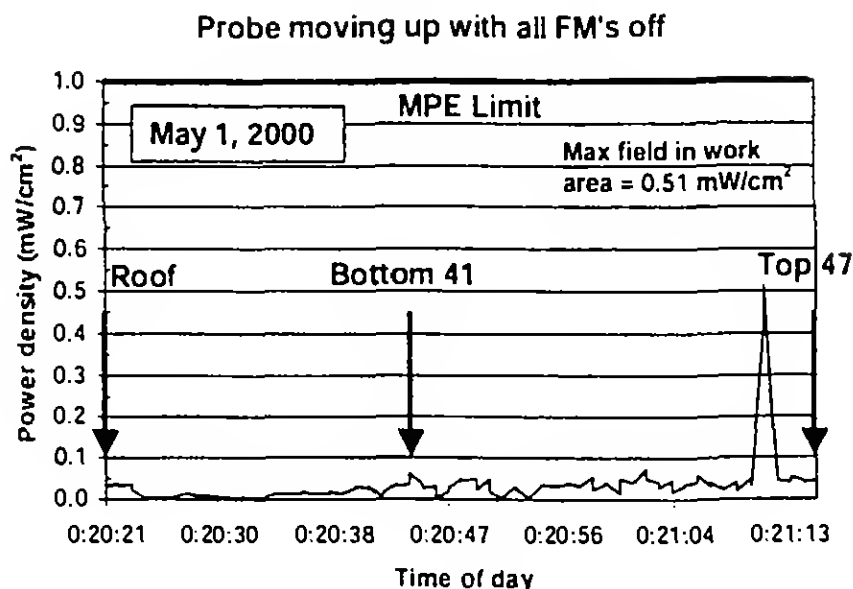
working area with the FM stations off. During the measurements, it was noted, as shown in Figure 22, that near the top of the channel 47 aperture, a narrow spike in the power density profile was observed. It is not apparent why this was observed but, in any event, the magnitude of the spike was less than 1 mW/cm^2 , the MPE limit in the FM broadcast band. The most likely source of this narrow peak in field would be the channel 31 antenna that operates at 2.820 kW of ERP at 572 MHz where the MPE limit is 1.9 mW/cm^2 . Thus, this value, while not clear what the source was, is less than the MPE for either the FM band or the UHF spectrum.

Figure 22. Plane wave equivalent power density measured parallel to antenna mast on May 1, 2000, with normal broadcast operations but with all FM stations off and probe moving up.

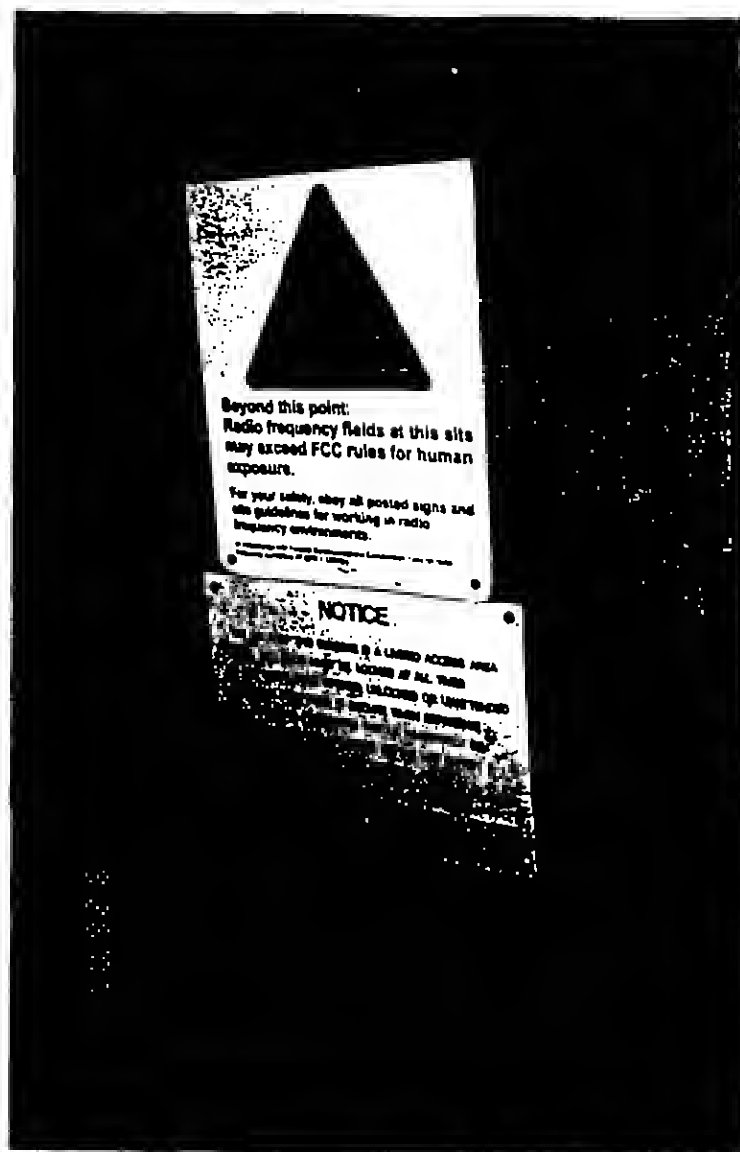
Photo #5: Signage at door to roof – One World Trade Center.
